# Bamboo under the Microscope

By Wolfram Schott  
2006

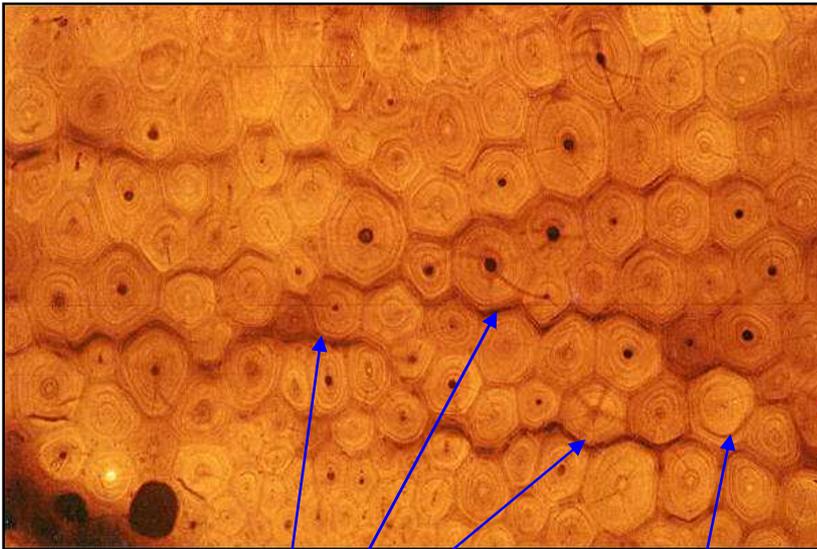
**Fig. 12**

cracks along cell borders

crack within cell

A picture taken from the central part of Fig. 11. Desiccation cracks, or fissures, following the walls of the cells have appeared. These split up the vascular bundles into a large number of sub-units. The cells are no longer snugly "glued" to each other. They have shrunk. The intercellular pectin is probably destroyed or cooked off. Some cells show circular cracks even within them, following the secondary walls (cf. Figs. 6 and 7). A bamboo treated such can no longer take up bending loads. The fibers will move along the cracks, shear strength is dramatically reduced.

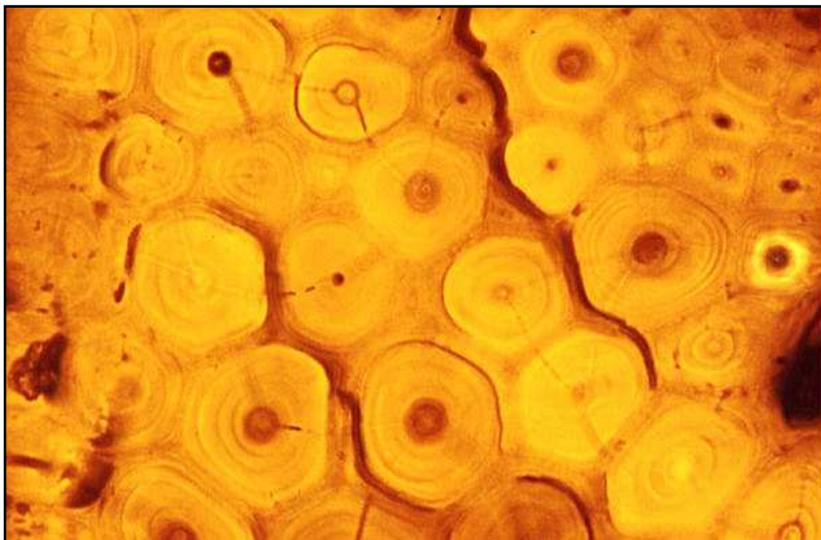
**Fig. 13**

A larger magnification of another part of Fig. 11. The "assembly of cells", the vascular bundle, is virtually destroyed: cracks along cell walls, many small cracks within the cells. The "polylamellate wall structure of the fibers" (cf. Fig. 7) seems partly destroyed, possibly due to breaking-up of the lignin-polymers into monomeric units. This sample had contained 6 % water (air-dried) and lost a total of 15 % (by weight) during heat-treating. Compare with Fig. 6.

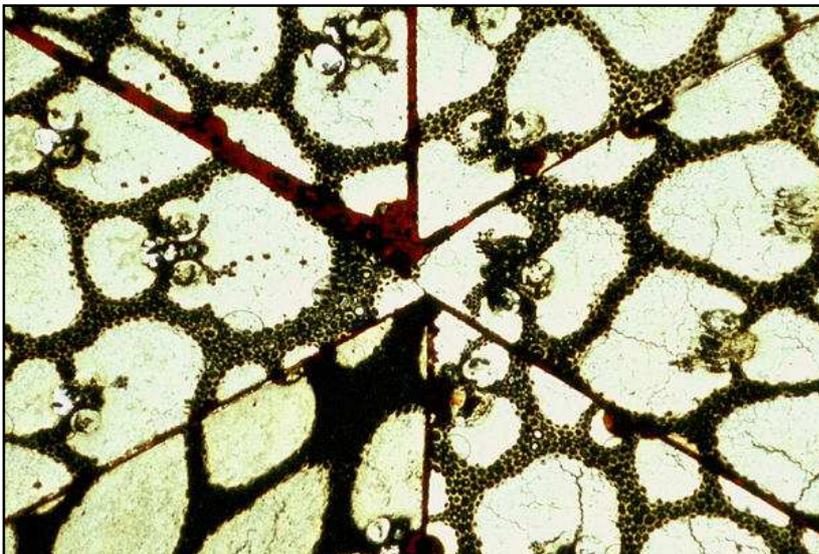
**Fig. 18**

Center of a rod, butt joint. Another hand-planed rod. Perfectly planed strips, precise 60° angle. The inner apexes are **not** planed (or sanded) off. The result is seen: the two horizontal strips (left and right) overlap each other, wedging the top-left one outwards, hence a thicker glue line. The whole center is disturbed, with uneven glue lines as another result. The outside geometry of this rod will be asymmetrical, with the three pairs of flats producing different values when measured. Resorcinol glue, undiluted.

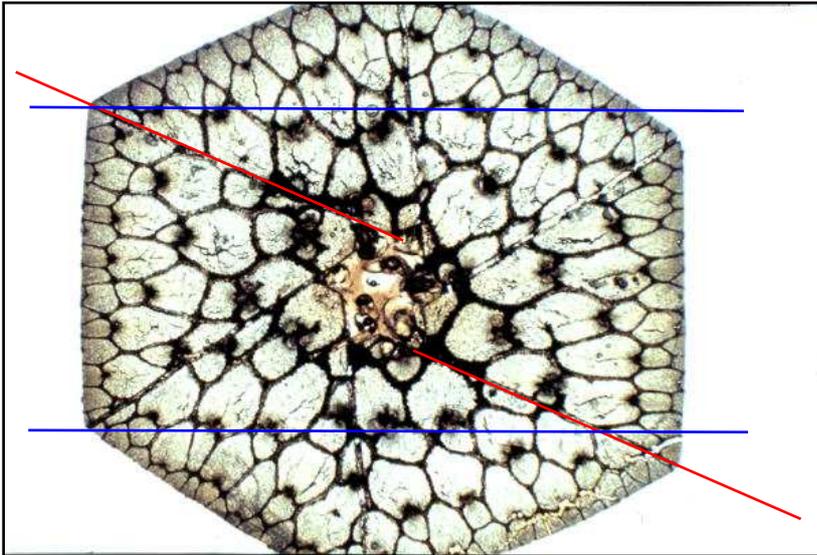
**Fig. 19**

A unique rod, hand planed. Six sided, but not really hexagonal (see blue lines). All six strips are off-shape (no equilateral triangle) by the same amount/angle. How this could be made, repeatedly and with some great degree of precision, I do not know. Maybe the planing form was made this way; more likely, the maker held the plane at an angle, not parallel to the surface of the planing form, with a locked wrist...

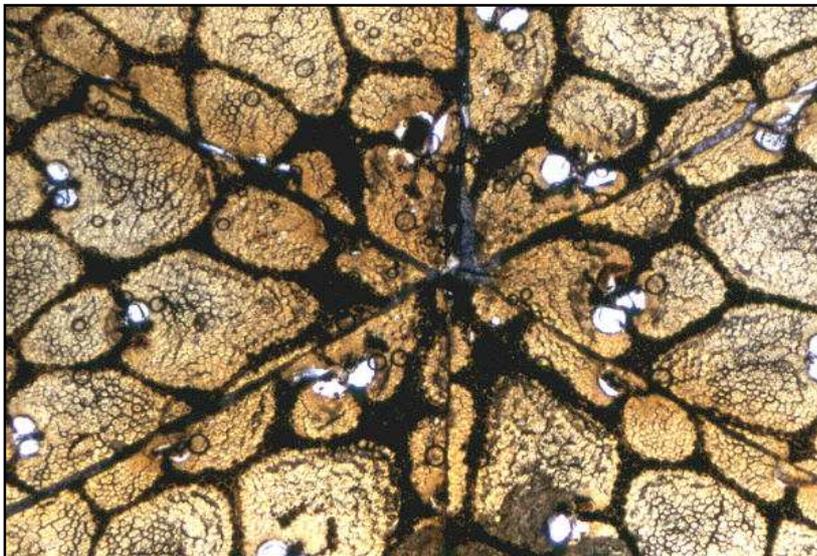
**Fig. 20**

Center of a milled rod. Perfect 60° angles, very thin glue lines. The cutters of the mill were bearing pretty hard on the bamboo, or they needed resharping badly, or they had a wrong cutting edge geometry: Along the inner (milled) surfaces, the cane has been burned to a rather brown colour, due to friction. Very sharp and pointed apexes.

This "scorching" of milled strips along their inner surfaces is frequently observed.

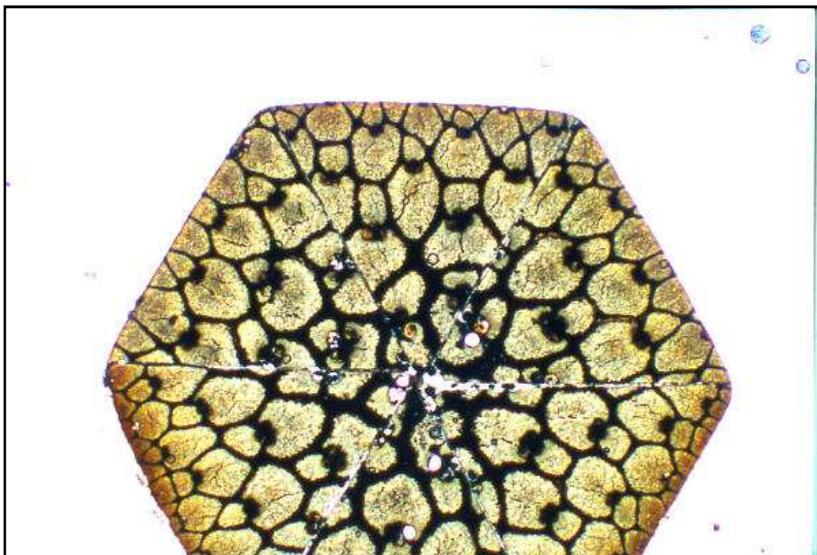
**Fig. 21**

Cross section through top section of a hand planed rod. The inner apexes could have been removed. This is a flamed rod. The outer, or surface, areas of the strips are brown (to the naked eye really dark brown). This is best seen at bottom left and right strips. The high temperature of the flame reaches approx. 0.3 – 0.5 mm (0.012 – 0.019 in) deep into the bamboo. This means for the last 5 or 10 inches or so of the top that most or the entire top diameter has been scorched, making it brittle.

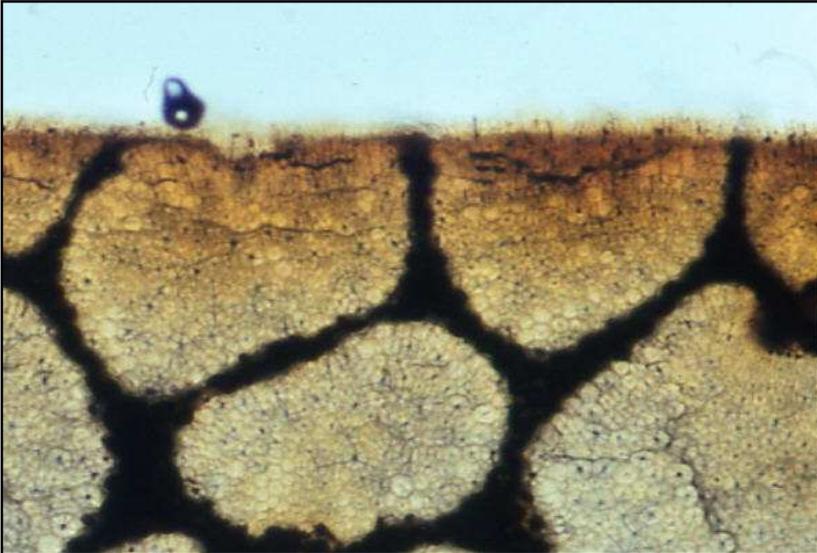
**Fig. 22**

Long side of picture: 0.41 mm (0.016 in)  
 Detailed view from above rod, Fig. 21. Under strong magnification, shrinking-cracks can be observed in the outermost vascular bundles. They run parallel to the surface. The largest cracks right under the surface, where heat was strongest, thinner ones deeper down. The individual cells begin to separate from each other, shear strength is reduced, and it is liable to break. And this is precisely why I got this rod in the first place. It had been stressed and the surface fibers had split into what looked like small brushes in several places.

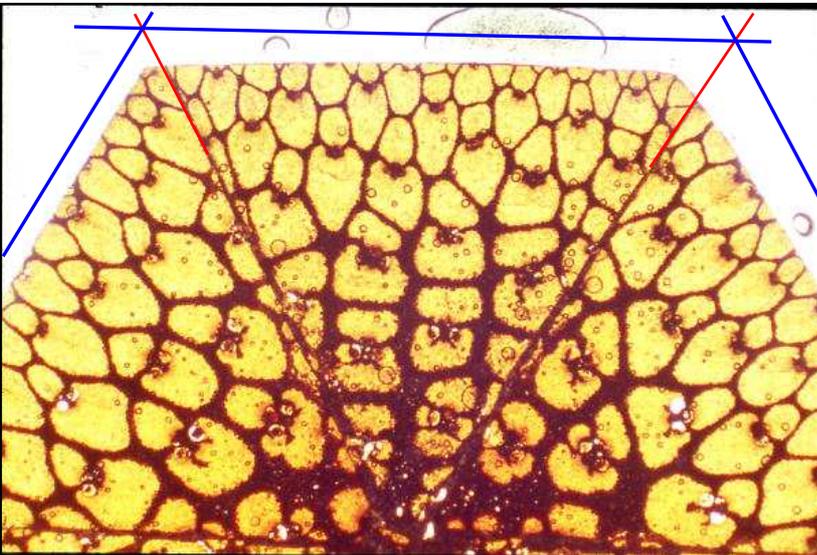
**Fig. 26**

Cross section through butt piece. Milled rod, 60.5 degrees center angle. Another example of rather heavy surface sanding. I have attempted to reconstruct the original outlines by lengthening the glue lines (red) and adding the possible original surface (blue). Compare the last three pictures with respect to geometry, and size/distribution/ density of vascular bundles with Fig. 27.

Some larger trapped air-bubbles at top, and many tiny ones within the rod section.

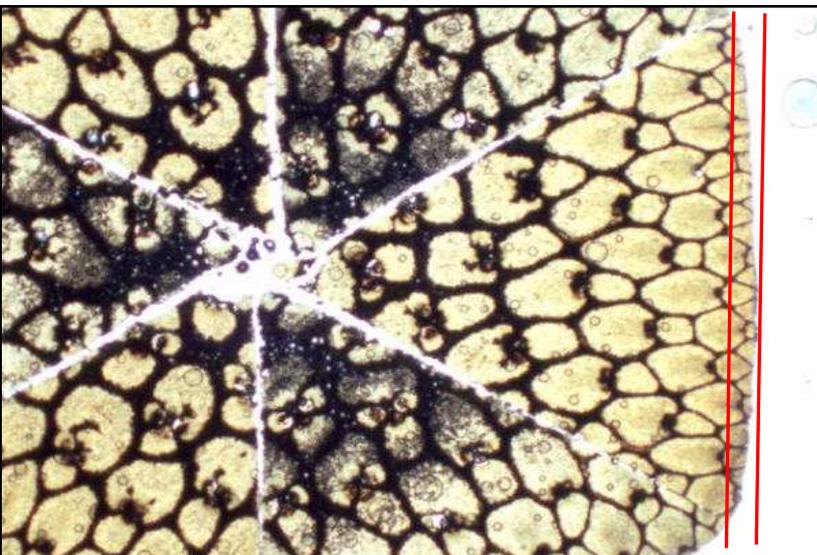
**Fig. 27**

Cross section through butt piece. The strips are milled with 61.5° angle. During glue-up in the binding machine the strips had room enough to rotate a little (clockwise), but they are still symmetrical around the center. Black: three rather bad strips, with inner vascular bundles being destroyed (possibly the result of fungus attack). The outer surface follows the culm-curvature. Had it been sanded or scraped flat, this would have removed a considerable amount of bamboo: 0.25 mm (0.01 in), see red lines. This problem is discussed in "Garrison", page 76.

Remark: Comparing Figs. 24, 25, 26 with Fig. 27, I would rather want to take off the enamel with sandpaper, carefully following the natural curvature of the culm. A true hexagonal shape, with perfectly flat outer surfaces and knife-sharp corners might look very "professional". However, it will also sacrifice a good deal of the most valuable outer powerfibers, especially in butts. Using hand-scrapers or the ubiquitous Stanley 212 scraper carelessly is liable to shave off not only the very thin skin, but also to dig into the topmost vascular bundles rather quickly. Using sandpaper one can actually watch the "uncovering" of the fibers through the "under enamel". Another negative aspect of sharp corners is shown further down, in the chapter on varnish.

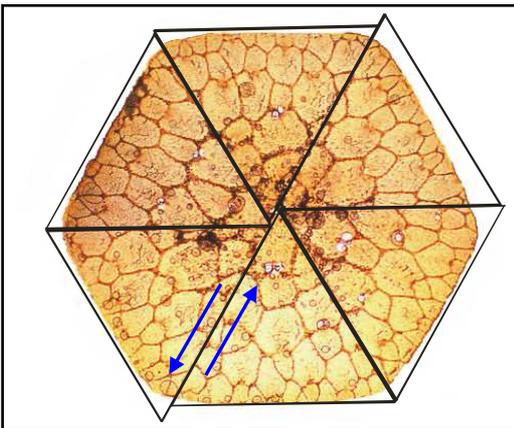
**Fig. 32**

Using Adobe Photoshop, I have removed the black threads of the guide winding in Fig. 31, plus the guide foot and the varnish. With Coral DRAW, I have constructed six equilateral triangles (with 60° angles) and of equal size. These are placed over the six strips of the rod section. The bottom strip determined the size (height) of the triangles. The result shows the probable original outline of the glued-up strips, provided nothing has been removed from the flat of the bottom strip. It also shows that the two "halves" of the rod section have moved along a glue line in opposite directions, by approximately 0.2 mm (0.008 in). See blue arrows. Sanding off the glue and some powerfibers (most on top right strip), possibly followed by polishing with steel wool (well-rounded corners) prior to varnishing has rectified this mishap ...

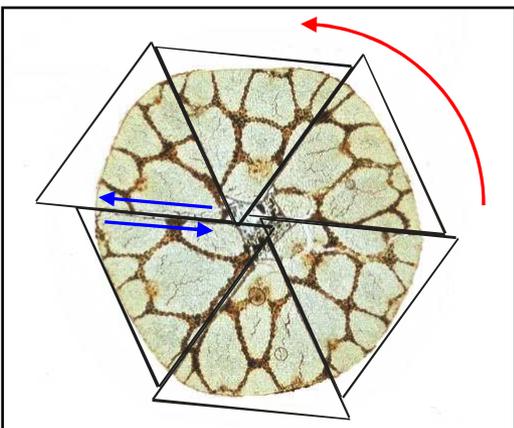
**Fig. 34**

Again, I have removed the red threads of the intermediate winding. Six equilateral triangles of equal size are placed over the six strips of the rod section. The bottom-left strip determined the size (height) of the triangles. The result shows the probable (minimum) original outline of the glued-up strips, provided nothing has been removed from the flat of the bottom-left strip. It also shows the rotation of the strips, the arrow indicating the direction of the binding thread on the first run through the binder. In addition, a displacement has happened, moving two halves of the rod in opposite directions along a glue line. See blue arrows. The rotation/lateral movement and hence the corners protruding over the flats are the result of too much torque first time through the binder with this delicate top.

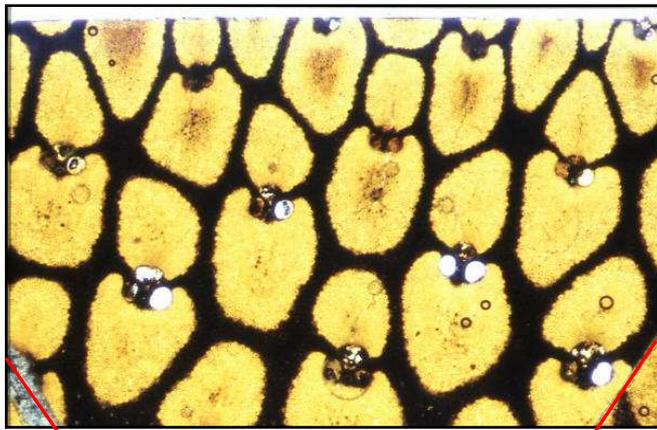
**Fig. 40**

One strip of a milled rod. Surface (top of picture) heavily sanded or scraped. The vascular bundles are large/coarse and their original position in the culm has been rather deep below the surface. White circles are mayor vessels, the sort that is seen in the inner (left) half of Fig. 1. This strip has 64 % "powerfibers" and 36 % "pith".

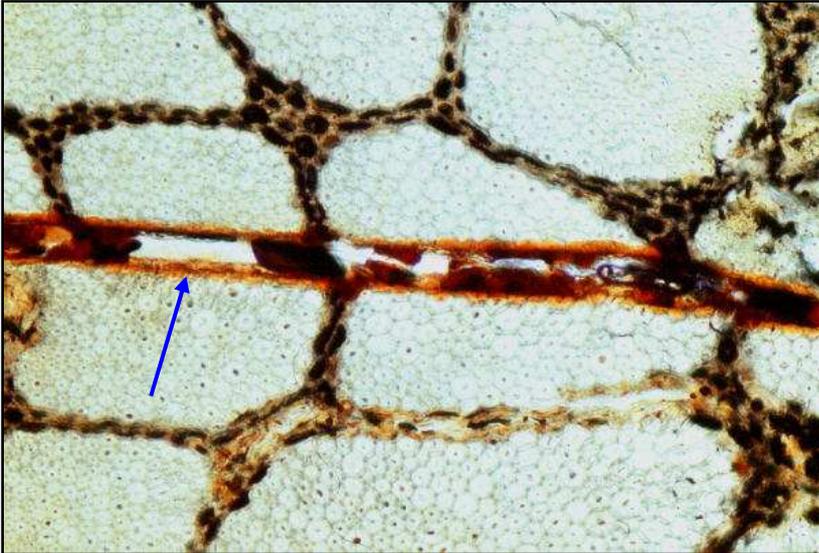
**Fig. 46**

Long side of picture: 1.3 mm (0.051 in)  
 Strongly diluted resorcinol glue. This has not really penetrated any deeper, either. However, it has left open voids, the alcohol having evaporated. Small lumps and crusts of cured glue sit in some places on either side of the joint. Red seams in the fibers (blue arrow) indicate that there once had been glue. Nutshell grains from the glue seem to have prevented a closer fit of the strips, hence a slightly broader glue line (0.05 mm = 0.002 in). Such a defect glue joint is liable to delaminate eventually, since shear-forces cannot be adequately distributed to the bamboo.

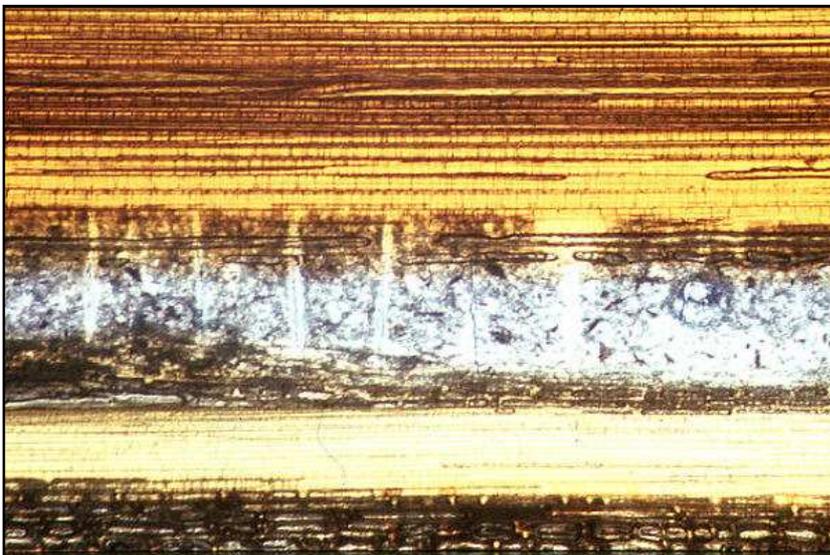
**Fig. 47**

Long side of picture: 1.3 mm (0.051 in)  
 A glue joint prepared parallel to the axis of the rod. Numerous cracks can be seen at short distances from each other. Maybe these developed as shrinking cracks during the curing of the glue (I think it is a melamin-based glue, but I am not sure). Maybe, also, they are the result of the rod's bending back and forth thousands of times, the glue being too brittle to withstand it.

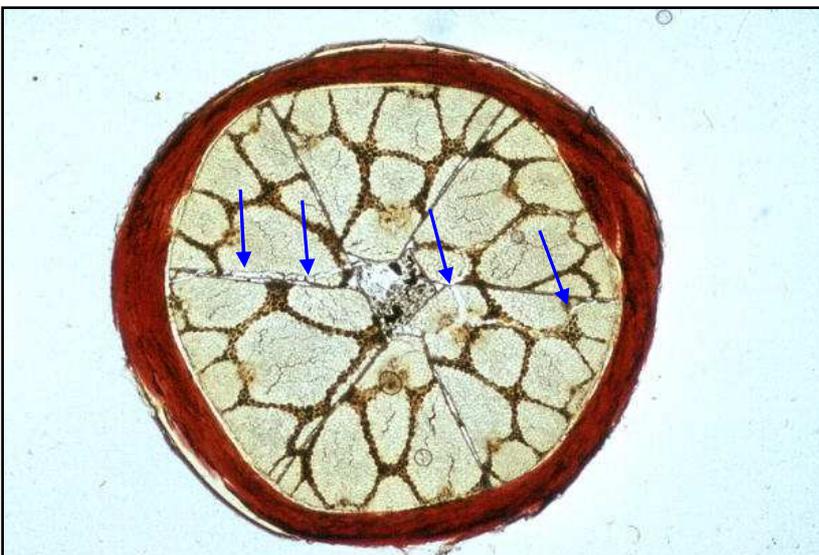
**Fig. 48**

Long side of picture: 3.2 mm (0.126 in)  
 Cross section of milled rod top. Heavily sanded flats and corners, the rod is more round than hexagonal. Flat-to-flat dimensions of bamboo somewhere between 1.6 and 1.9 mm (0.063 and 0.075 in). Sample prepared through an intermediate winding. The drawn-under end of the thread located on top right flat. The strips are rotated counter clockwise around the center. This rod had broken lengthwise in two halves over a distance of some 20 cm, or ¾ foot, and was factory repaired (reglued), see arrows. Same photo as Fig. 33.

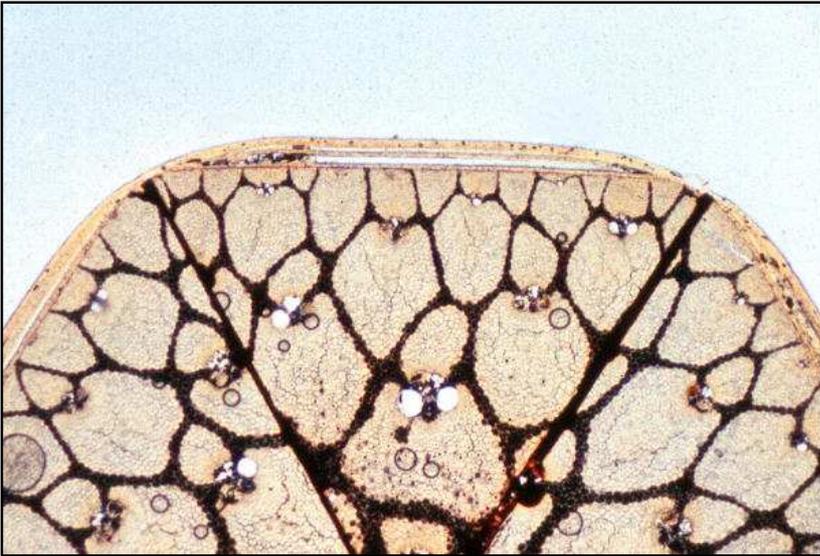
**Fig. 50**

Long side of picture: 6.6 mm (0.26 in)  
 Cross section of a hand planed rod. Flats are scraped/sanded flat, corners rounded. Resorcinol glue. The rod is dip-varnished three times, using an alkyd-type varnish containing polyurethane, (information given from the maker). The layers have separated, best seen at top flat. Possibly the prescribed open-time of the varnish (waiting-time between two successive coats) had been exceeded.

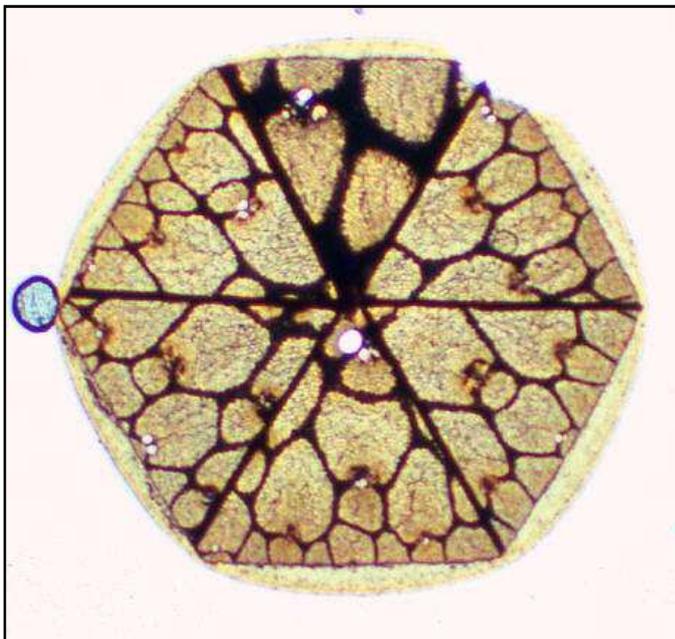
**Fig. 56**

A small chip has broken off from the right top corner during preparation of the sample. Trapped air bubble at left.
