# Bamboo under the Microscope

By Wolfram Schott  
2006

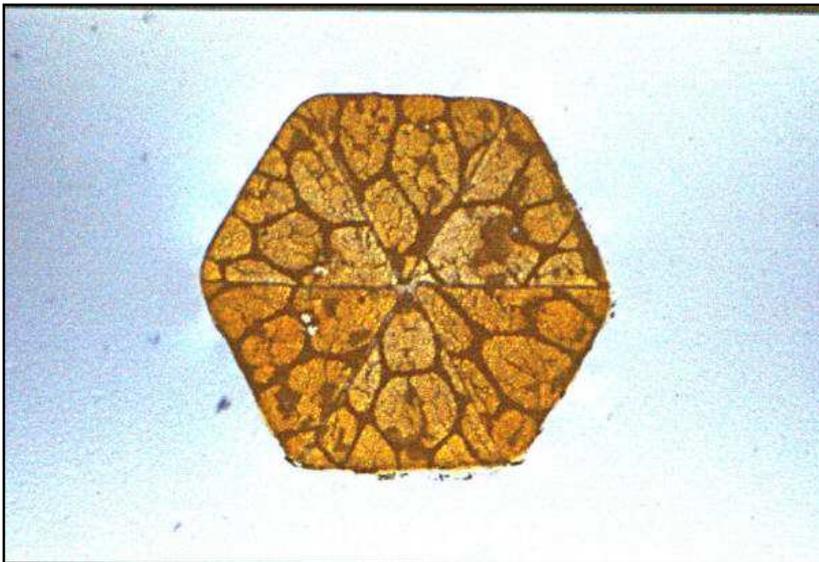
**Fig. 36**

Long side of picture: 3.2 mm (0.126 in)  
 Cross-section through leeway cut-off from the tip of a 7' # 3 rod, milled. Flat-to-flat dimensions 1.46 mm (0.0574 in), very symmetrical. A three-and-three strip configuration (3 taken from one culm, and 3 from another). The top, bottom-left and bottom-right strips have a darker colour than the remaining other three. Not a very sharp photo, but I included it to demonstrate perfect milling and gluing, even down to such delicate dimensions. Hand planing can achieve the same precision, of course. However, mind your vascular bundles. There are not many left in such a tip.

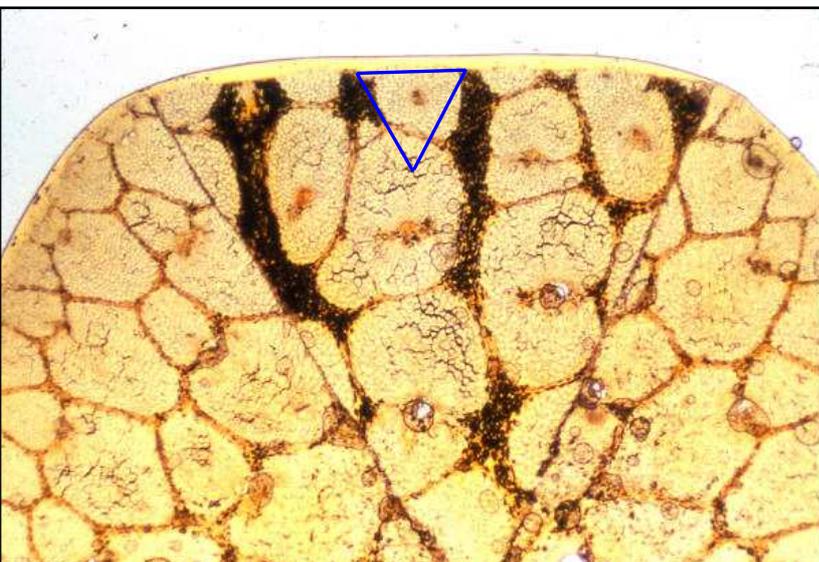
**Fig. 37**

Long side of picture: 6.6 mm (0.26 in)  
 Cross section through milled rod, 60°, varnished, and cut through node. Few and large vascular bundles, with much parenchyma; compare with the two other strips.  
 In blue, to scale, a triangle of 0.7 mm (0.027 in) depth (cf. Fig. 36). It may contain next to no, or one half, or even one whole, vascular bundle of inferior quality (cf. Figs. 1, 5 and 6). Three such nodes in one position will produce a very weak area indeed. I have seen several rods that broke, within the last 10 to 15 inches or so, of the tip, in such node stations.

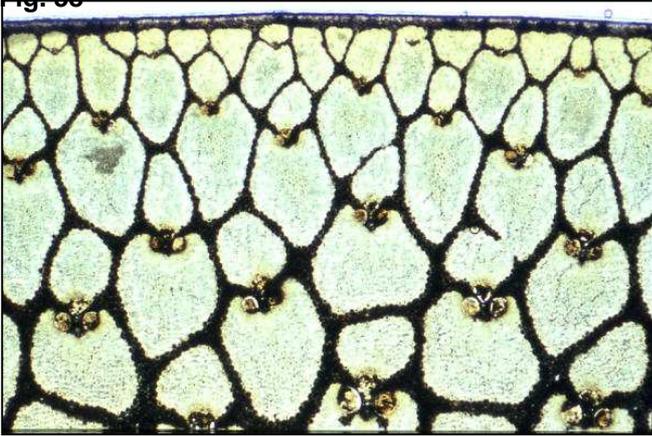
**Fig. 38**

A cross section through the outer third or so of a culm. Skin on top of picture. This is an average culm, and the area of this picture contains 75 % vascular bundles, or "powerfibers", and 25 % parenchyma, or "pith".

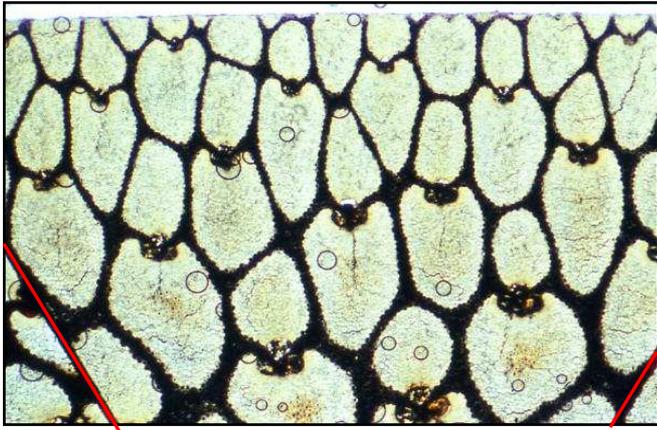
**Fig. 39**

One strip of a hand planed rod. The glue lines are indicated in red near bottom left and right corner. On top of picture, the surface of the strip. (In all 3 Figs. 39-41). An ever so slight rounding is seen, following the natural curvature of the culm. Little more than the skin has been removed. Compare size and distribution of vascular bundles with Fig 34. This (whole) strip has 74 % "powerfibers" and 26 % "pith".

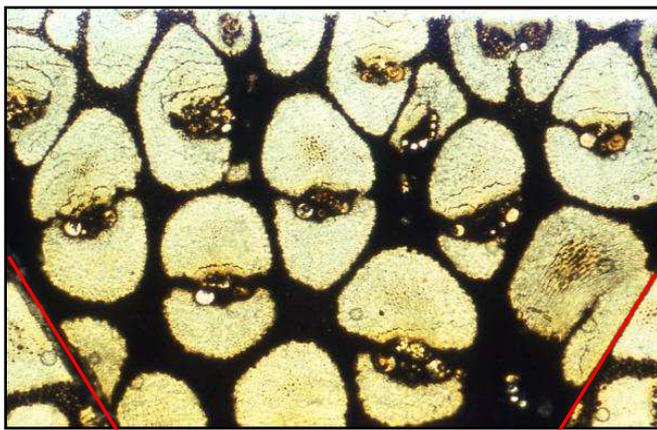
**Fig. 41**

One strip of a node, milled rod. Surface heavily sanded. Very coarse vascular bundles, typical for nodes. Node not pressed, but sanded flat. Only 60 % "powerfibers", and 40 % "pith" in this strip.

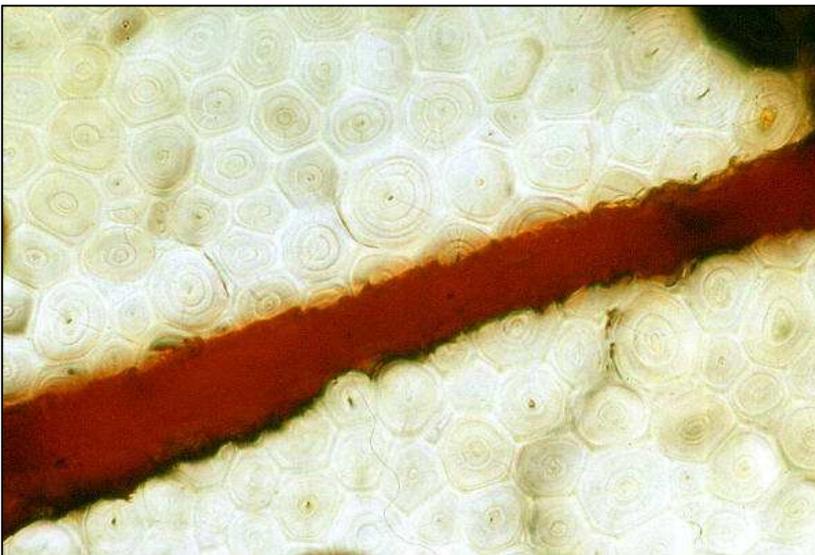
**Fig. 44**

Long side of picture: 0.23 mm (0.009 in)  
A glue-line under high magnification. The fibers (cells), which have a diameter of 0.01 mm (0.0004 in) to 0.02 mm (0.0008 in), are cut lengthwise, halving many. This needs a sharp iron. Resorcinol glue is used here, undiluted. Thickness of glue-line is approximately 0.02 mm (0.0008 in). The glue has not penetrated into the fibers.

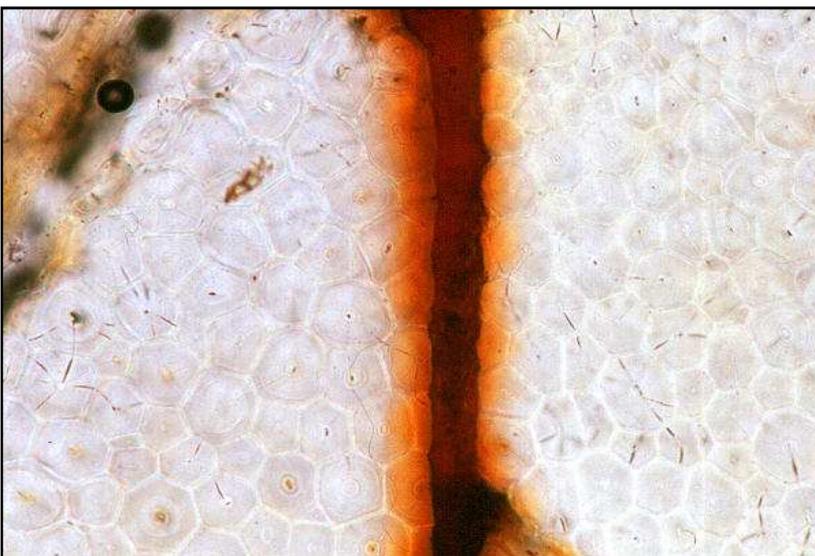
**Fig. 45**

Long side of picture: 0.23 mm (0.009 in)  
Moderately diluted resorcinol glue. This has penetrated into the fibers, giving a better hold for the glue. Thickness of glue-line 0.01 mm (0.0004 in). About an equal penetration into the fibers has taken place.

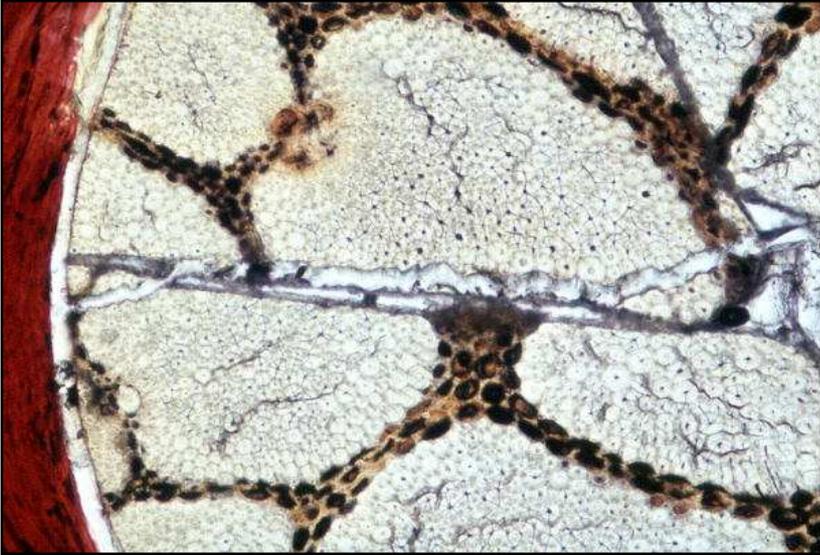
**Fig. 49**

Long side of picture: 0.84 mm (0.033 in)  
 Photo taken from the left side of Fig. 48, with stronger magnification. The break went partly through bamboo (vascular bundles, or "powerfibers"), partly along the initial glue line, continued through the center of the rod (cf. Fig. 48) and again through and along borders of vascular bundles, through parenchyma cells.

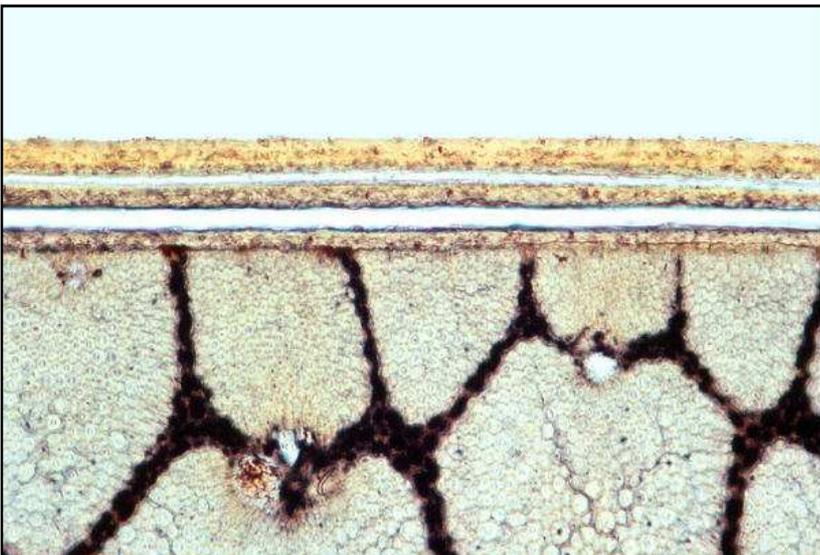
**Fig. 51**

Long side of picture: 0.8 mm (0.031 in)  
 A closer look. The first layer of varnish adheres to the rod (bamboo), but not the successive two. From top to bottom, I have measured:

0.042 mm = 0.00165 in varnish  
 0.007 mm = 0.00027 in air  
 0.026 mm = 0.00102 in varnish  
 0.023 mm = 0.00090 in air  
 0.017 mm = 0.00067 in varnish

Total: 0.115 mm = 0.00451 inches combined varnish+air in the middle of the flat. Three layers of varnish alone: 0.085 mm = 0.00334 in.

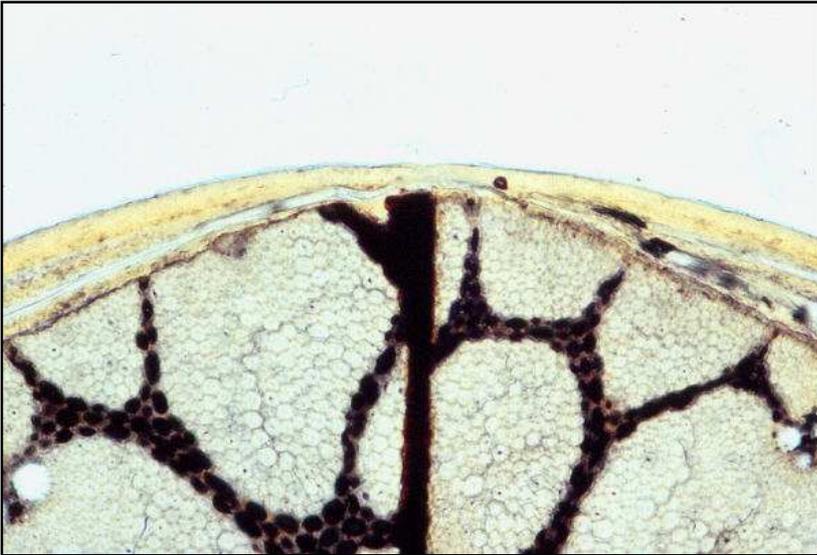
**Fig. 52**

Long side of picture: 0.8 mm (0.031 in)  
 A higher magnification of the top left corner of Fig. 50. In spite of three layers of varnish, the resulting thickness is only 0.018 mm (0.0007 in). The varnish has built up on the flats, due to surface tension. Another three dippings would have produced a round rod, without contributing considerably more varnish to the corners. And here the corners had been rounded! Had the corners been knife-sharp, even less (or no) varnish would have been deposited there.  
 In between the right side layers, some debris has been deposited during preparation of the sample.

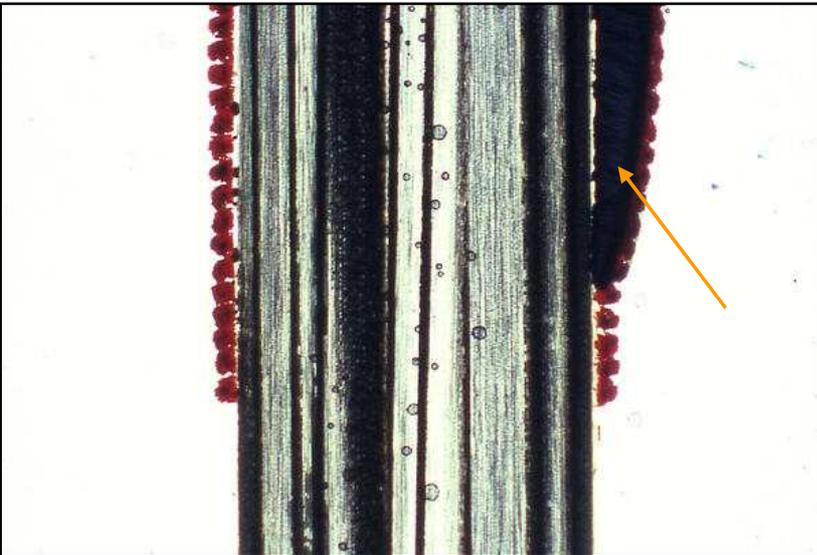
**Fig. 53**

Long side of picture: 6.6 mm (0.26 in)  
 Longitudinal cut through a guide winding. The black guide foot is on the right side (steel, not transparent, of course, see arrow). Under the foot, a thin layer of varnish, also on the opposite side, under the red winding threads (nylon in this case). The varnish is not really visible in this picture, due to strong light having been used. Many trapped air bubbles along the center of the section.

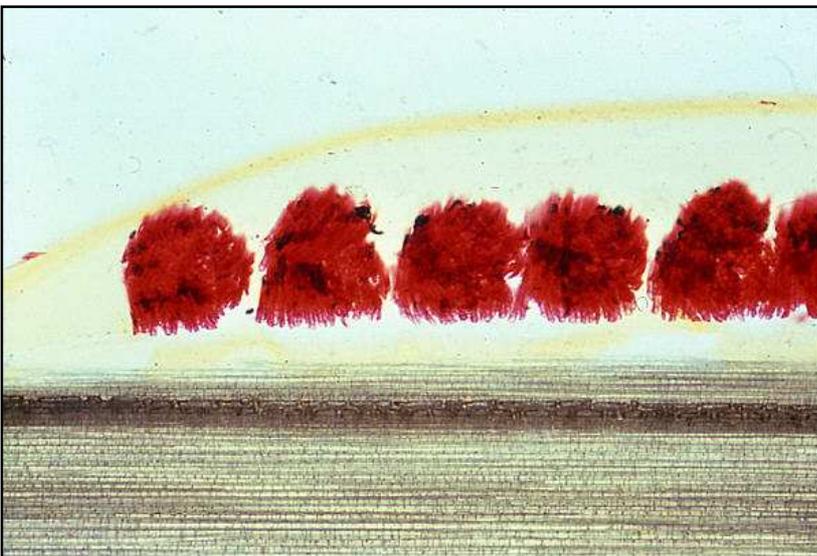
**Fig. 54**

Long side of picture: 1.3 mm (0.051 in)  
 Here the varnish becomes visible (partly crossed polarizer/analyzer in the microscope). Clearly visible a yellow layer of varnish under the threads, which appear to be floating above the surface of the bamboo, and varnish between and above the threads.

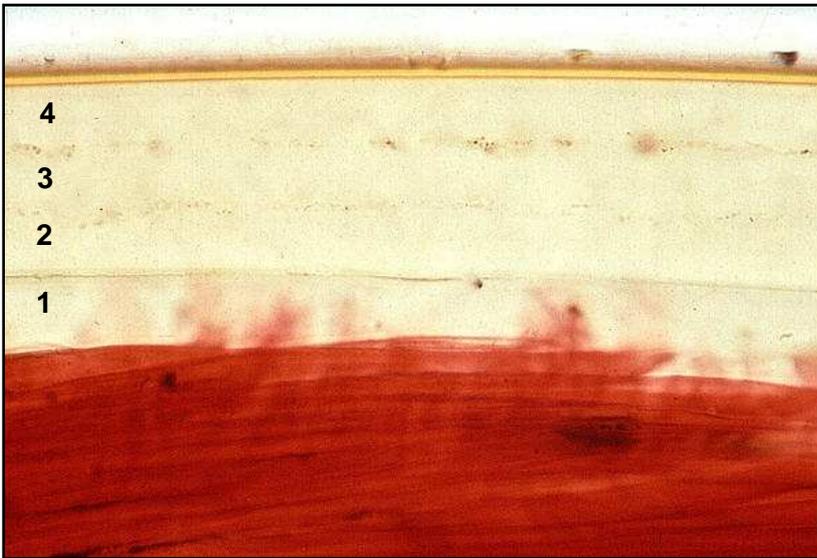
**Fig. 55**

Long side of picture: 0.32 mm (0.012 in)  
 Cross section through guide winding. The individual fibers of the thread are visible. Further four layers of varnish, with a good bond between each other. Bottom layer (1) belongs to the soaking of the windings prior to varnishing the whole rod. It has a slightly lighter colour. Maybe a different varnish was used for priming. The whole story is: 1. the blank has been varnished. 2. The guides have been wrapped on and soaked/filled with varnish. 3. The rod has been varnished three times (2, 3, 4). The topmost dark yellow line is due to light refraction between varnish and embedding epoxy; an optical artifact.
